PRACTICAL CONSIDERATIONS OF INSPECTING POST-TENSIONED BRIDGES

Huw T Williams
Director
Testconsult limited
11 Trinity Court
Risley, Warrington
Cheshire, WA3 6QT

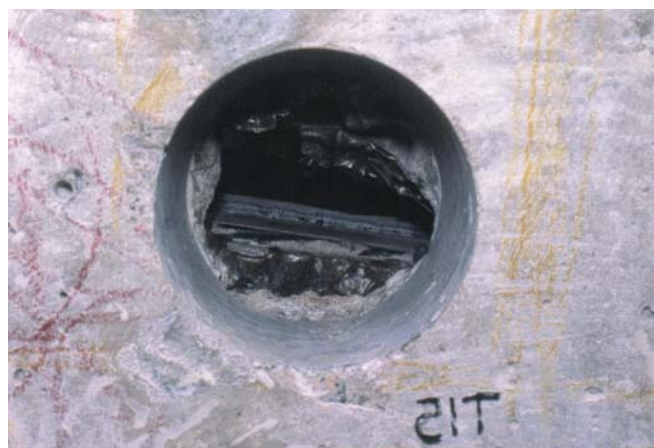
Figure 1. Tendons exposed by Diamond Overcoring

Diamond over-coring of intrusive holes to enlarge access can also introduce water, used as a coolant, into voided tendon ducts. There is also the additional risk of severing tendons during these procedures. Alarm systems are available that connect to coring and drilling equipment to indicate when contact with metallic duct sheathing is made. However, should the duct sheathing be plastic, or not exist, the alarm or cut-off will not work, and in the case of coring a slight contact can be sufficient to severely damage tendons.
